Results of an 18 Year Case Study: Examination, Testing and Evaluation of DARLYN® 1100CB from TVA Cumberland

Background:

TVA has long specified the use of DARLYN 1100CB in many of the expansion joints in its coal-fired power plants. Recently, the opportunity arose to remove an intact belt from an expansion joint after approximately 18 years of service. This material was returned to Saint-Gobain Performance Plastics (SGPPL) for evaluation.

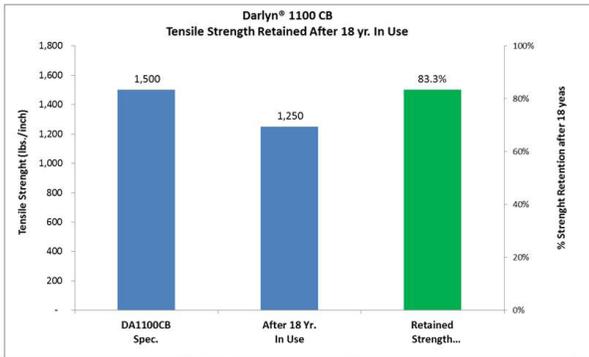
- 77% of Breaking Strength¹ in the warp² (machine) direction
- 94% of Breaking Strength¹ in the fill (cross-machine) direction

Strength retention after Flexfold test³ of 18 year old material was very good:

- 83% retention in warp direction
- 94% retention in fill direction

Darlyn after 18 years continuous performance retained 83% of its original specified tensile strength

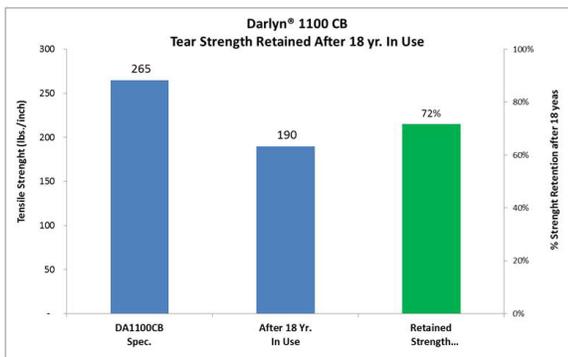
Darlyn after 18 years continuous performance retained 72% of its original specified tear strength

Tear strengths remain quite high after many years in service. The reduction in tear strength in both directions (warp and fill) corresponds to the changes seen in breaking strength values. Overall, the property retention of the material indicates stable operation of the system – significant deterioration in properties is often seen in systems with multiple starts and stops, excessive flutter or misalignment, or other severe stresses.

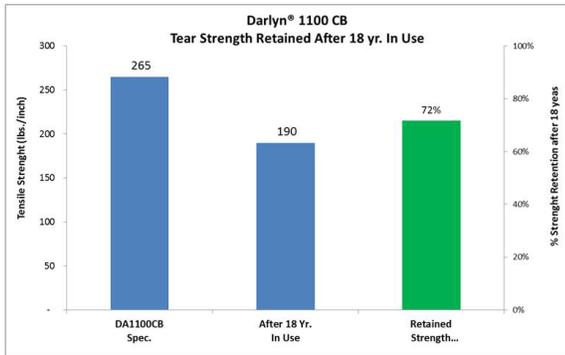
Darlyn after 18 years continuous performance retained **72% of its original specified tear strength**

- Breaking strength in the warp direction averages more than 70% higher than FSA recommendation for new material.
- Breaking strength retention after flexfold approaches 100%, while the FSA guidelines call for a minimum of 60% strength retention for new material.
- Values for trap tear strengths are at least 3X the minimum values recommended by the FSA for new material.
